DELAWARE RIVER BASIN  
DRECK CREEK, LUZERNE COUNTY

DAM F  
NDI ID NO. PA-00642  
DER ID NO. 40-13

HAZLETON CITY AUTHORITY  
PHASE I INSPECTION REPORT  
NATIONAL DAM INSPECTION PROGRAM

MAY 1979

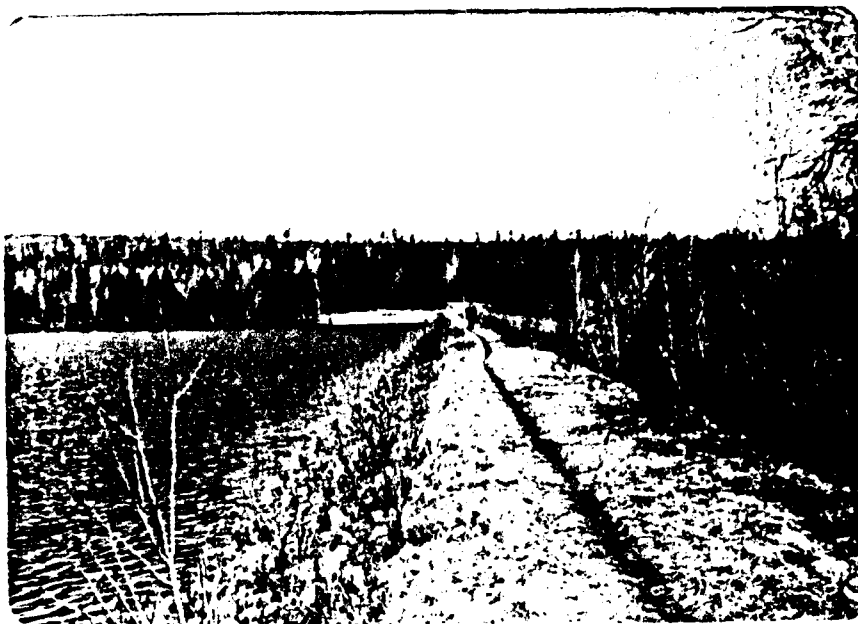
b. Embankment. The riprap on the upstream slope is in good condition. There is minor heaving of the riprap along the upstream slope. The riprap terminates 0.9 foot below the design top of dam elevation (Photograph A). Above the top of the riprap, the soil is soft and minor shallow sloughing has occurred all along the top. This sloughing was also observed at areas along the downstream edge of the top of the dam, where the riprap also terminates 0.9 foot below the design top elevation (Photograph C). The measured topwidth varies between 6 and 10 feet. Thick brush covers areas of the downstream slope. Mature trees are growing at the toe of the dam (Photograph C). Areas of the downstream slope are bulged and heaved (Photograph D). Smooth heaves start about 400 feet to the right of the outlet works and continue to the left. The heaves appear as 1-foot high ripples on the slope. The heaves transition to bulges about 140 feet to the right of the outlet works. The bulges have a much more peaked appearance. They extend all the way to the spillway at the left abutment. The largest bulge was estimated to be about 4 feet high. The heaves and bulges are generally near the toe of the slope.

(2) Embankment. The riprap being below the top of the dam is an erosion hazard when the pool is above spillway crest elevation.

A. Top of Dam and Upstream Slope

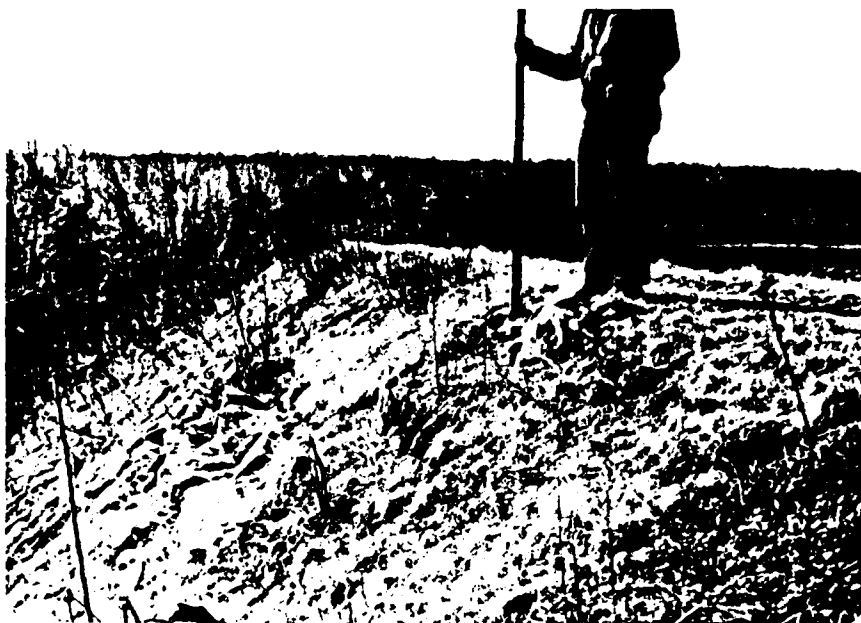
(2) Embankment. An inspection by the Commonwealth in 1928 noted that fill had recently been placed on the top of the dam. It is surmised that uncompacted soil was placed along the top of dam to fill in low areas and that an amount of overbuild was provided. This is probably the reason why the embankment is above its design elevation, minor sloughing occurred, and the existing top width varies. These conditions are not of particular concern. The brush on the slopes and the trees along the toe are undesirable. The bulges and heaves on the downstream slope are of concern. A 1928 inspection report by the Commonwealth noted that the paving on both slopes had just been relaid. The present bulges were first noted in an inspection by the Commonwealth in 1944. In that inspection report, the bulges were described as extending over a 50-foot length near the outlet works. Repairs were ordered, but apparently never accomplished. The present bulges are much more extensive. The heaves on the upstream slope are probably caused by poor construction grading; they are not of particular concern.

C. Sloughing at Top of Downstream Slope

(6) Monitor by any suitable means the scour, cracking, and deterioration of the concrete spillway walls, the sloughing near the top of the dam, and the heaves on the upstream slope. Take remedial action when needed.

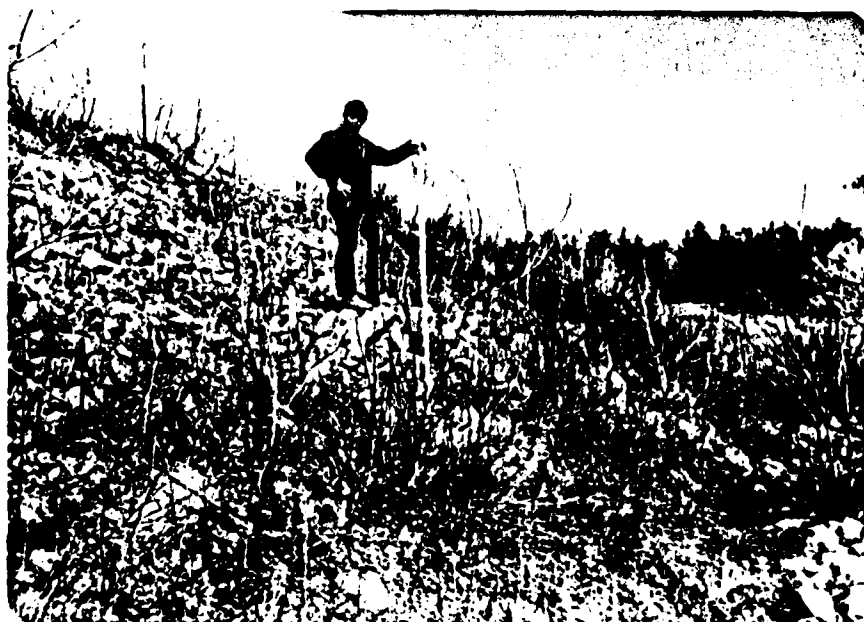
c. Operating Records. There are no formal records of operation. No evidence of instability on any feature of the dam has been noted, except for the bulges on the downstream embankment slope.

D. Bulges on Downstream Slope

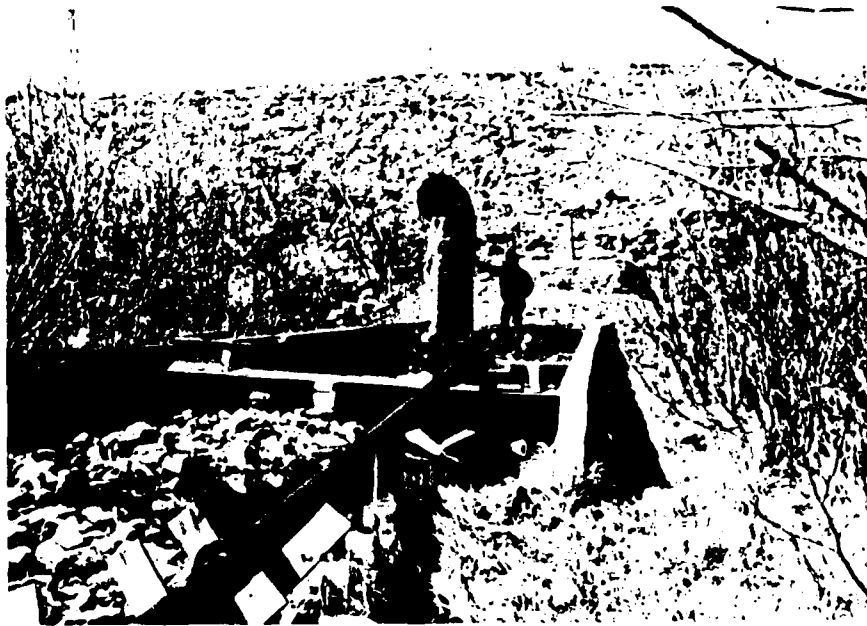
F. Outlet Works

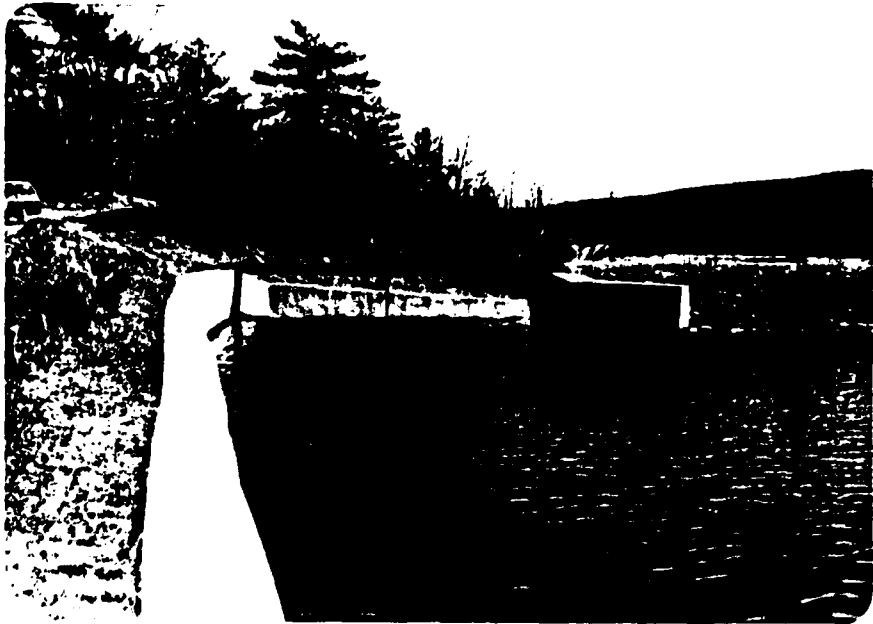
G. Spillway Approach

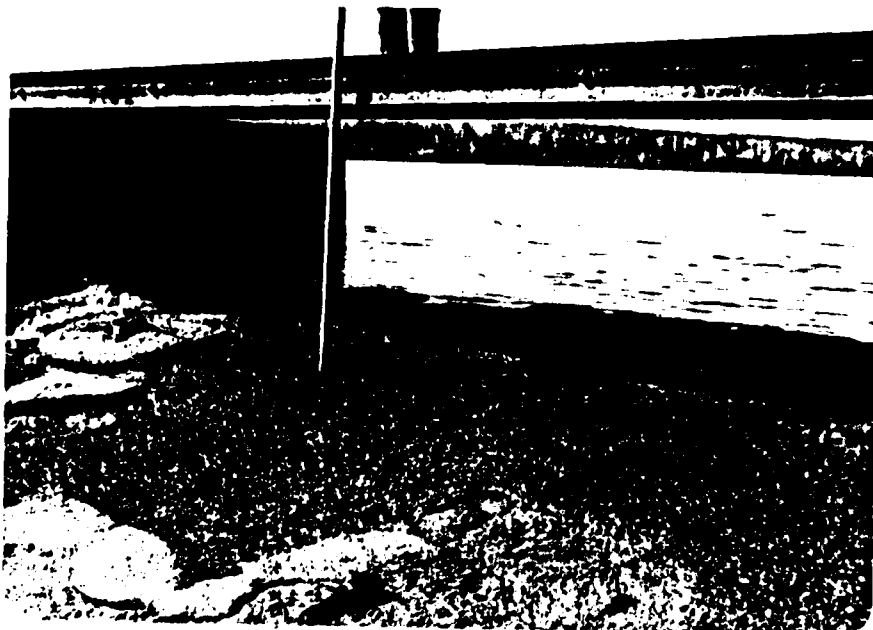
Although the spillway is in fair structural condition, the Owner has placed sandbags across the spillway crest (Photograph H). The sandbags are piled 0.5 to 0.7 feet high. The approach walls and training walls immediately downstream of the crest are covered with shotcrete (Photograph G). These walls have a minor amount of shrinkage cracks. One area of the wall shows evidence of relative movement. As the offset is covered with shotcrete, the movement is obviously not recent. Immediately downstream of the spillway crest, the slab is severely scoured (Photograph H). Further downstream, the slab is less severely scoured. The walls evidence minor signs of distress. The areas are sketched in Appendix B.

The spillway crest measured 29 feet. This is 1 foot shorter than the design crest length. A bridge extends across the spillway crest. Its low steel is at the design top of dam elevation (Photograph H). The bridge deck is beginning to deteriorate.

The Owner stated that the sandbags provide additional storage for periods when the system runs low on water. He considered this a "slight" deviation from approved operating practice. The sandbags are a serious hazard to the dam because they significantly reduce the spillway capacity. The bridge across the spillway crest has the potential to collect debris, which would further reduce the spillway capacity.

The deterioration of the bridge slab is not a hazard to the dam at present. Further deterioration could hinder access.

H. Spillway Crest

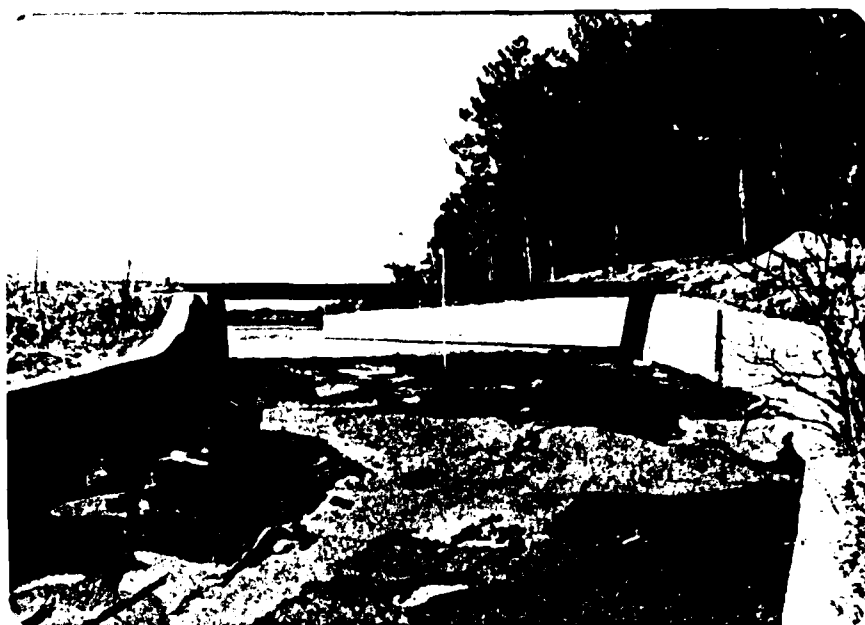
The scour observed at the spillway is an indication of the lack of maintenance. A review of the periodic inspections by the Commonwealth indicate that severe deterioration of the concrete had been continuing for many years before Tropical Storm Agnes. The plans prepared by Gannett Fleming Corrdry and Carpenter, Inc. (GFCC) to repair the damage caused by that storm indicated that scour holes in the slab from 20 to 90 feet downstream from the spillway crest were to be filled and that the slab from 90 to 150 feet downstream from the spillway crest was to be replaced. No repairs to the walls were indicated on the plans. The slab that was replaced is in good condition. The slab that was repaired is scoured, but not severely. The slab upstream of the repaired section is severely scoured. A discussion with GFCC's project manager indicated that this area was not scoured immediately after Tropical Storm Agnes. The scour is apparently recent. The shotcrete on the spillway walls is in good condition. The shrinkage cracking, minor bulging at one area, and leaching at another is not an immediate hazard to the dam. However, it is surmised that the shotcrete is 6 inches thick on each wall, which accounts for the 1 foot reduction from the design crest length.

I. Spillway Chute

(4) Repair the spillway slabs.
